ABBREVIATED PRELIMINARY ASSESSMENT CHECKLIST

Site Name: 9540 Niagara Falls Boulevard

Site Location: 9524/9540 Niagara Falls Boulevard

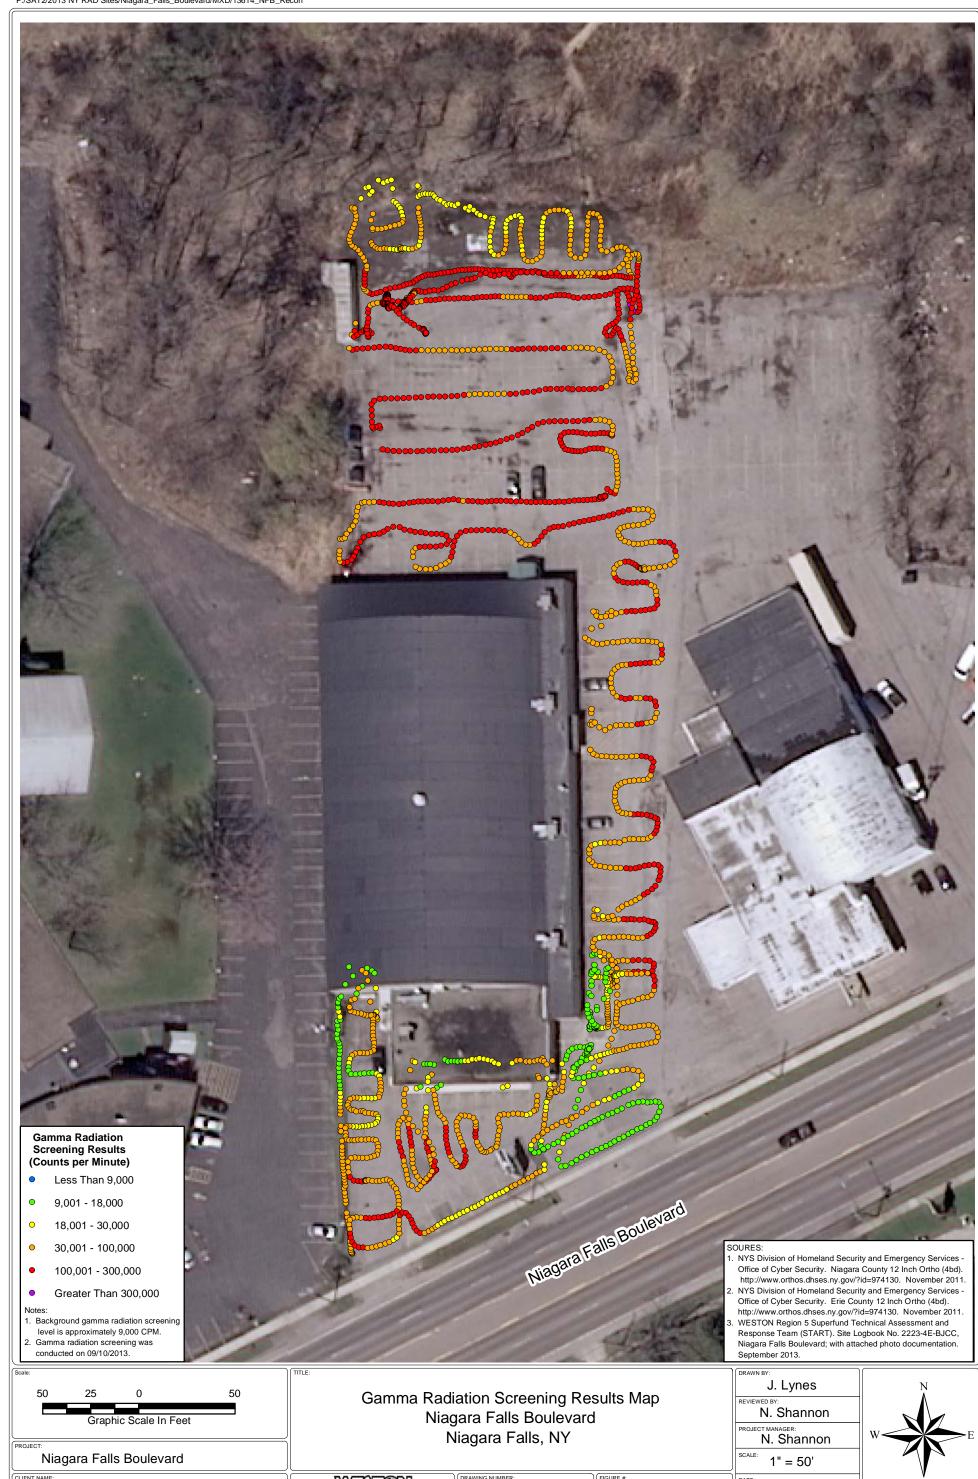
lot and overgrown brush area behind the building ranged between 30,000 and 40,000 cpm. WESTON also surveyed gamma radiation levels inside the building. Radiation levels at the back entrance were around 25,000 cpm. Once inside the building, levels ranged between 6,000 and 10,000 cpm. The property owner stated that the whole back area (e.g., the lockers, arcade area, and small bowling store) was raised 2 feet with concrete, and that the radiation levels inside the building in this area were greatly reduced as a result. The storage area behind the alley registered levels between 7,000 and 8,000 cpm. The side entranceway, which also had additional concrete added, had radiation levels between 10,000 and 14,000 cpm. Figure 3 depicts the gamma radiation levels of the exterior portion of the property detected during the survey.
